By way of professional guidance and advice from the engineering firm of Buckland & Taylor Ltd., offering 39 years experience in bridge design, independent checking, evaluation, retrofit, rehabilitation, and construction engineering for bridges of all types, the City of Trail has thoroughly examined the options relative to the use of the Old Trail Bridge.

Buckland & Taylor conducted its annual examination of the Old Bridge last fall and the results clearly indicate the structure cannot be used in any way, shape or form due to severe deterioration. Combined deficiencies to the strut, piers and chord make

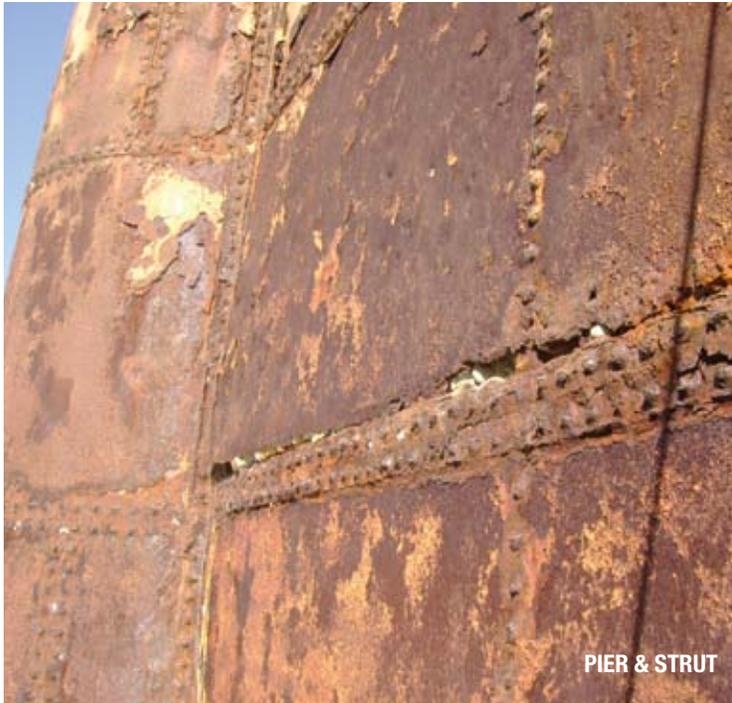
- Steel separated and no longer tied together
- Severe scaling where steel thickness has deteriorated from age

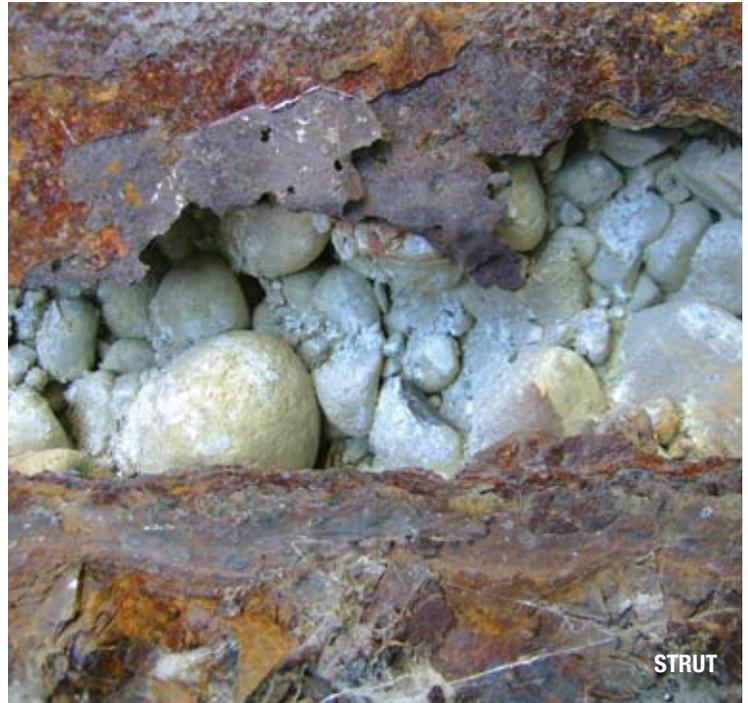
- Exposed aggregate
- Non-existent cement binding
- Complete erosion of steel

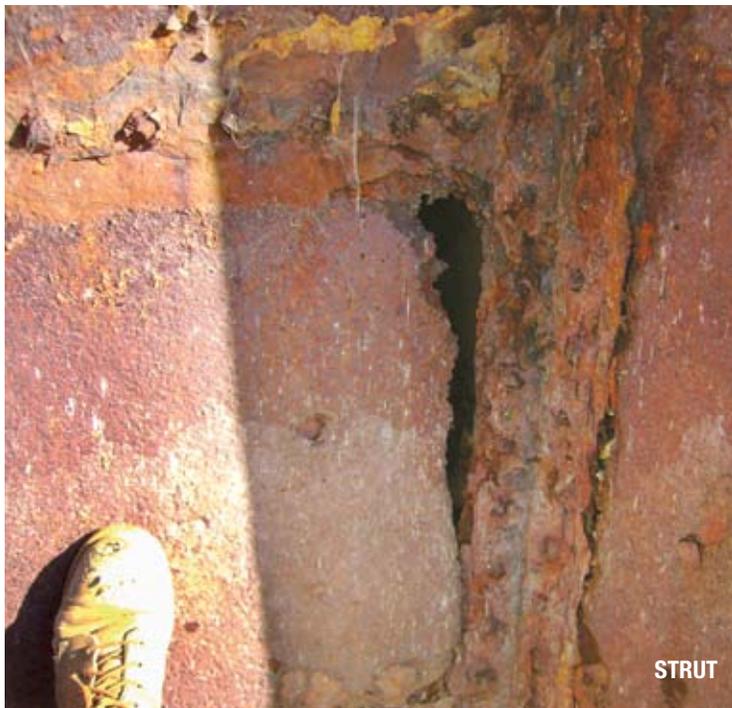
- Extreme deterioration of steel illustrating gaping holes
- Aggregate and cement absent inside pier

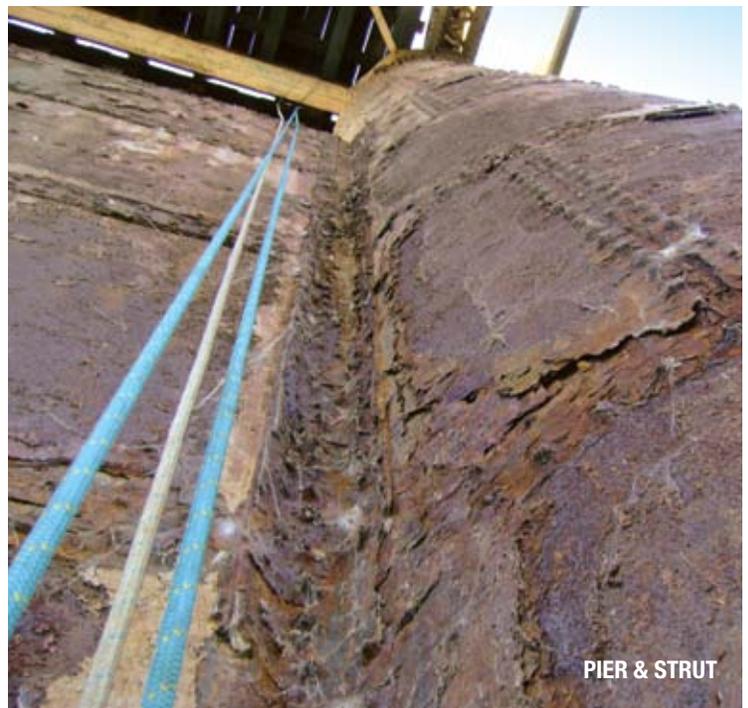
- Severe scaling with detached steel
