By way of professional guidance and advice from the engineering firm of Buckland & Taylor Ltd., offering 39 years experience in bridge design, independent checking, evaluation, retrofit, rehabilitation, and construction engineering for bridges of all types, the City of Trail has thoroughly examined the options relative to the use of the Old Trail Bridge.

Buckland & Taylor conducted its annual examination of the Old Bridge last fall and the results clearly indicate the structure cannot be used in any way, shape or form due to severe deterioration. Combined deficiencies to the strut, piers and chord make

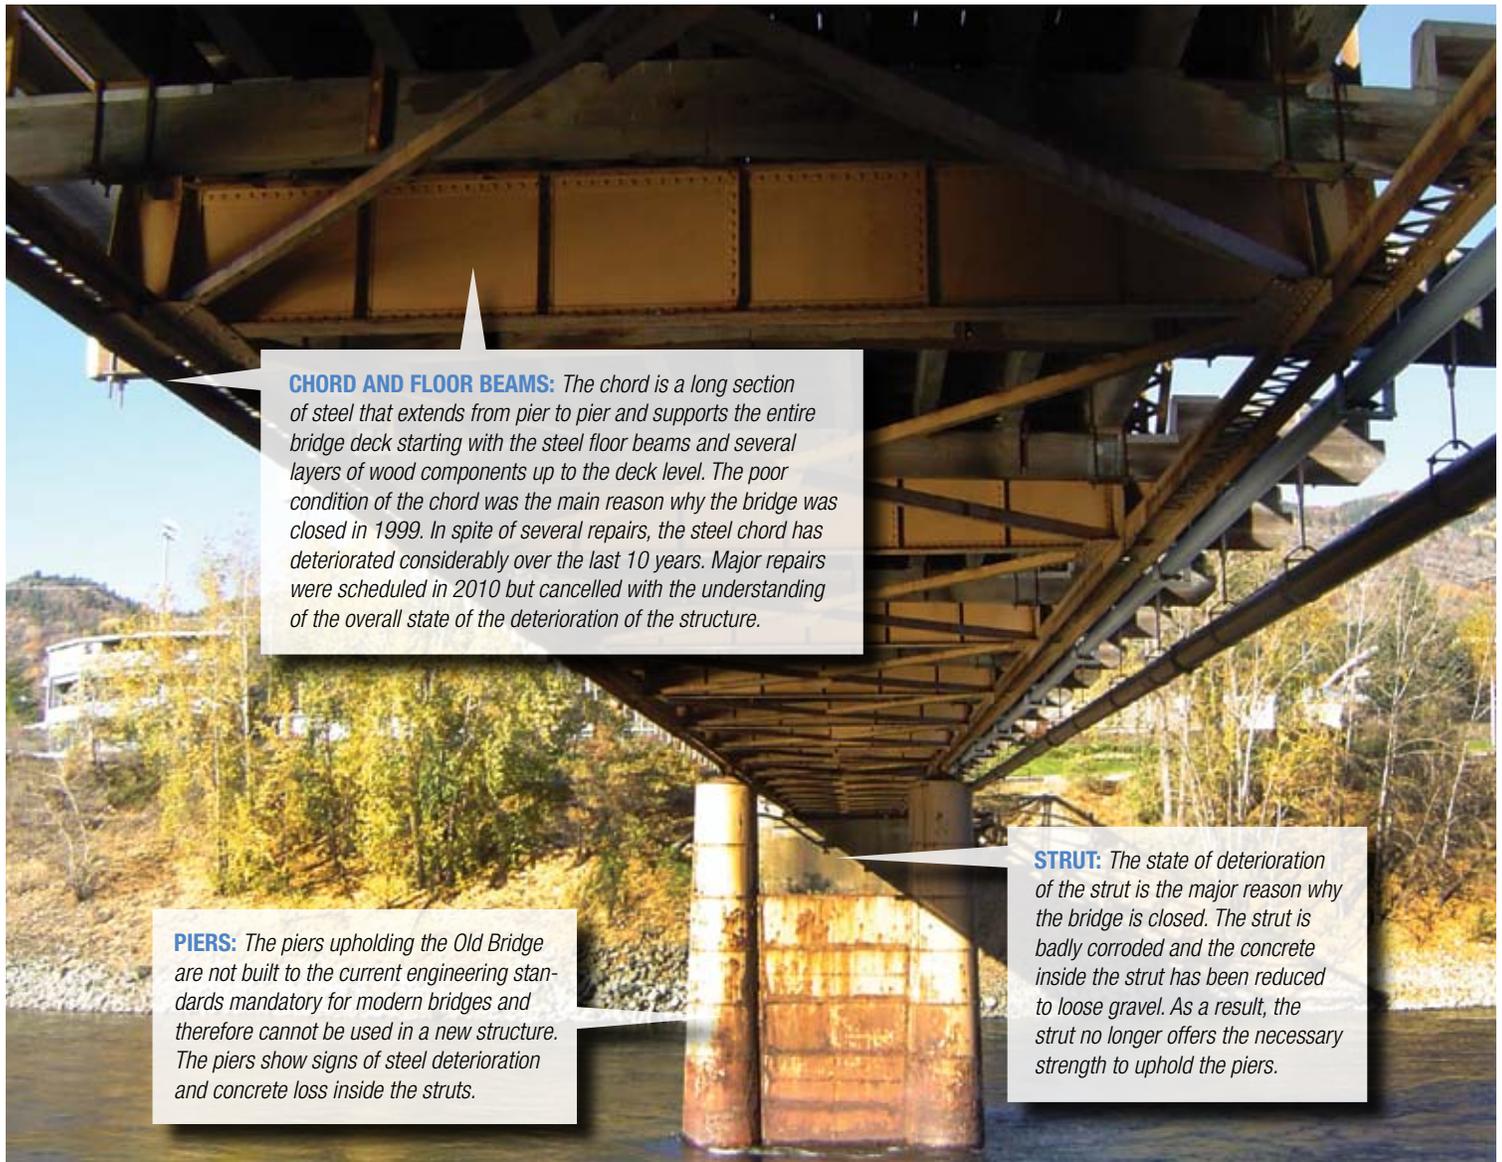
CHORD AND FLOOR BEAMS: *The chord is a long section of steel that extends from pier to pier and supports the entire bridge deck starting with the steel floor beams and several layers of wood components up to the deck level. The poor condition of the chord was the main reason why the bridge was closed in 1999. In spite of several repairs, the steel chord has deteriorated considerably over the last 10 years. Major repairs were scheduled in 2010 but cancelled with the understanding of the overall state of the deterioration of the structure.*

PIERS: *The piers upholding the Old Bridge are not built to the current engineering standards mandatory for modern bridges and therefore cannot be used in a new structure. The piers show signs of steel deterioration and concrete loss inside the struts.*

STRUT: *The state of deterioration of the strut is the major reason why the bridge is closed. The strut is badly corroded and the concrete inside the strut has been reduced to loose gravel. As a result, the strut no longer offers the necessary strength to uphold the piers.*
